# Manhole Inspection Summary

Manhole # S19E\_\_005MH

**Location** Address: **2201 SARATOGA-PENROSE** Cross Street: **SMALLWOOD ST**

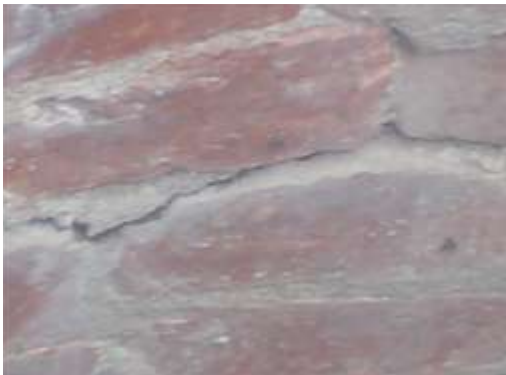
Defect 6

**Corbel** Material: **Brick** ☐ Parged Type: **Concentric/Eccentric**  
Condition: ☐ Sound ☒ **Cracked** ☐ Root Intrusion ☐ Loose Brick ☐ Deteriorated  
Infiltration: ☐ None ☐ Joint ☐ Cracks ☐ Mortar ☐ Roots ☒ **Wall**

CRACKED CORBEL

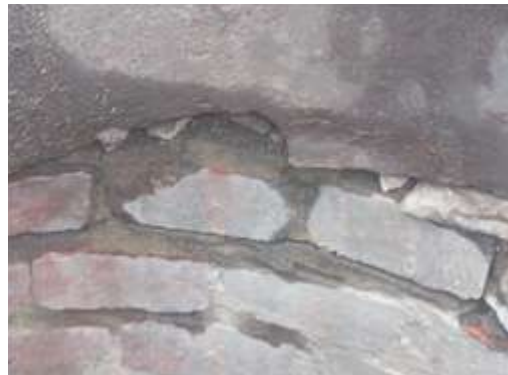
Defect 5

**Frame** Offset: **3** (in.) Condition: ☐ Sound ☒ **Cracked** ☐ Leaks

BROKEN FRAME

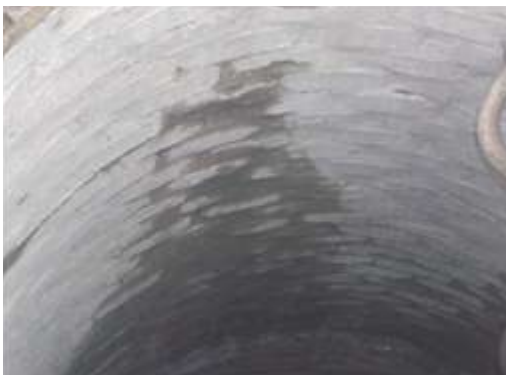
Defect 4

CORBEL WALL INFILTRATION

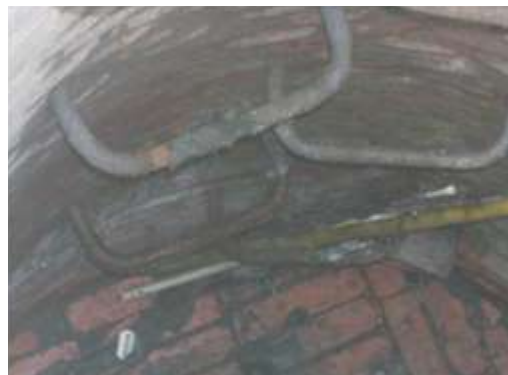
Defect 3

**Steps** Count: **6** Missing: **0** ☒ **Corroded**

CORRODED STEPS

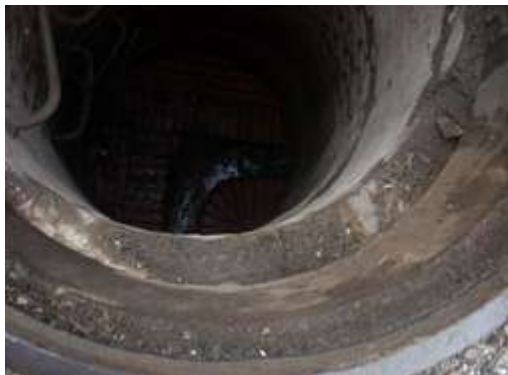
Defect 2

FRAME OFFSET

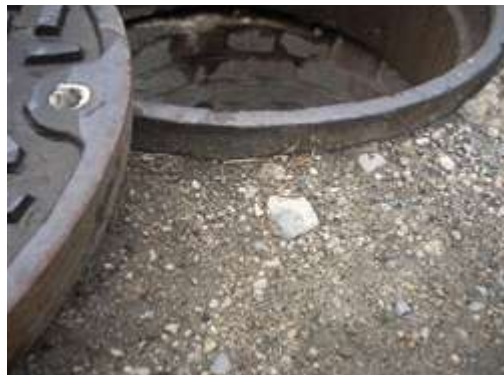
Defect 1

GRADE ADJ

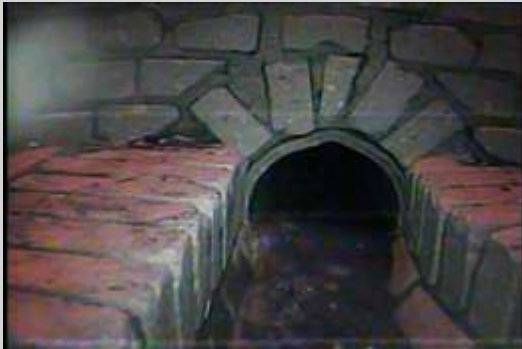
12 O'Clock Outflow

8 in. Circular Gravity Sewer  
Pipe Out @ 12 O'Clock

Pipe Height: **8.4** (in.) Rod and Bar (Angled)  
Pipe Material: **Clay** ☐ Pipe Lined  
Invert Depth: **10.32** (ft.) Flow Characteristics: **Slow**  
Deposits: ☐ None ☐ Mud ☐ Sludge ☒ **Debris** ☐ Grease  
Silt Depth: **2** (in.) Deposits Extent: **Light**  
Infiltration: **None** Pipe Seal Cond: **Sound**

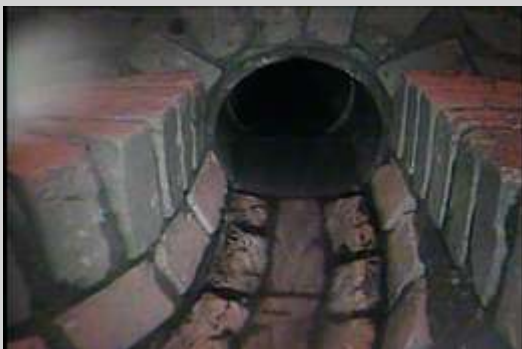
3 O'Clock Inflow

8 in. Circular Gravity Sewer  
Pipe In @ 3 O'Clock

Pipe Height: **8.4** (in.) Rod and Bar (Angled)  
Pipe Material: **Clay** ☐ Pipe Lined  
Invert Depth: **10.14** (ft.) Flow Characteristics: **Slow**  
Deposits: ☒ **None** ☐ Mud ☐ Sludge ☐ Debris ☐ Grease  
Silt Depth: (in.) Deposits Extent:  
Infiltration: **None** Pipe Seal Cond: **Sound**
